Figure 1 – View of the damaged zirconium impeller. Several sections have been removed for evaluation. Note the linear defects (arrows). (0.2X)

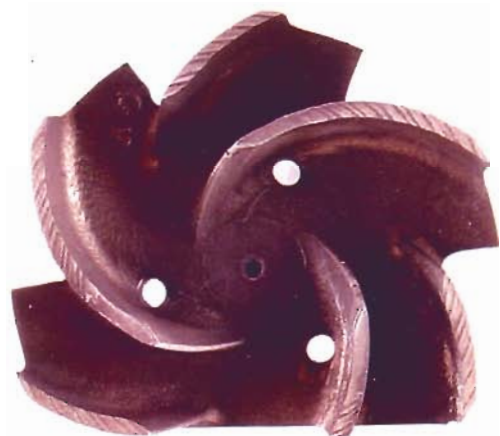
Figure 2 – View of the undamaged impeller. Portions have been removed for evaluation. Its surfaces are covered with a dark, protective oxide film. (0.2X)

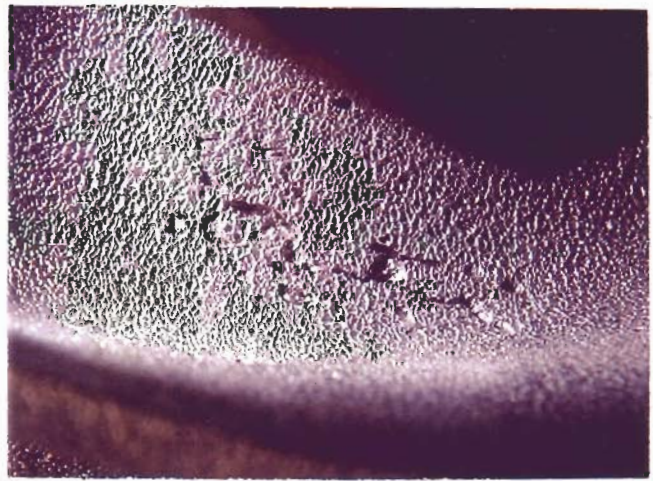
Figure 4 – Patches of corrosion pitting are evident on the damaged impeller surface. (1.1X)

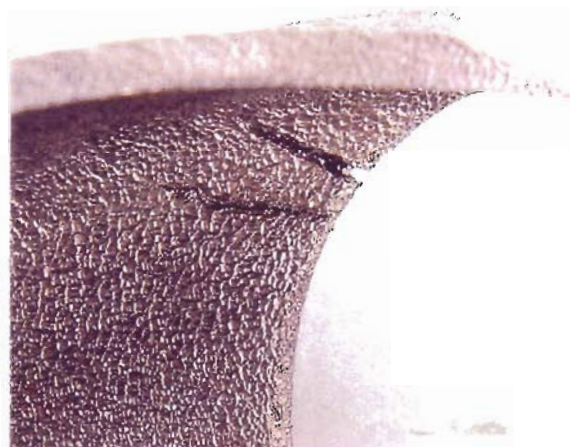
Figure 5 – A closer view of two deep linear defects on an impeller blade tip. (1.2X)

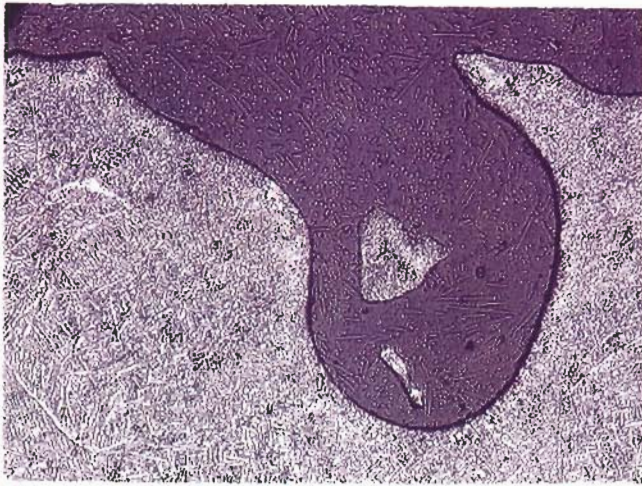
Figure 6 – Photomicrograph showing a cross section of a corrosion pit. (50X)

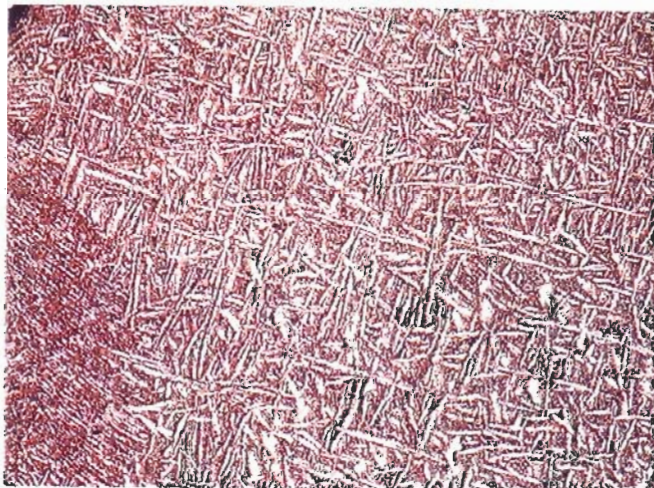
Figure 8 – Both impellers display a Widmanstätten structure. (100X)

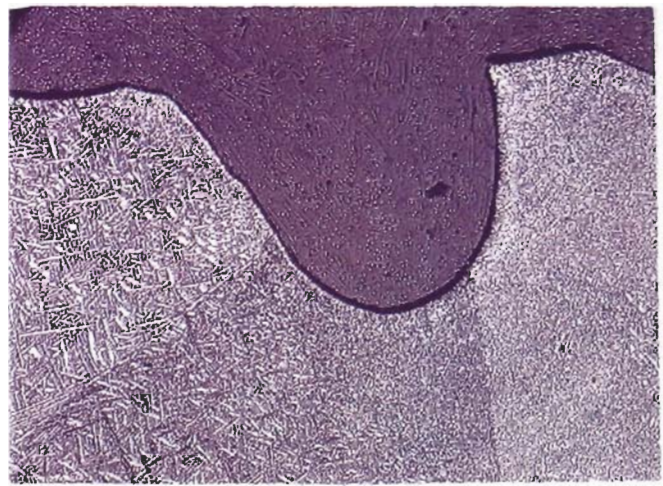
Figure 7 – Metallographic cross section through another corrosion pit. (50X)

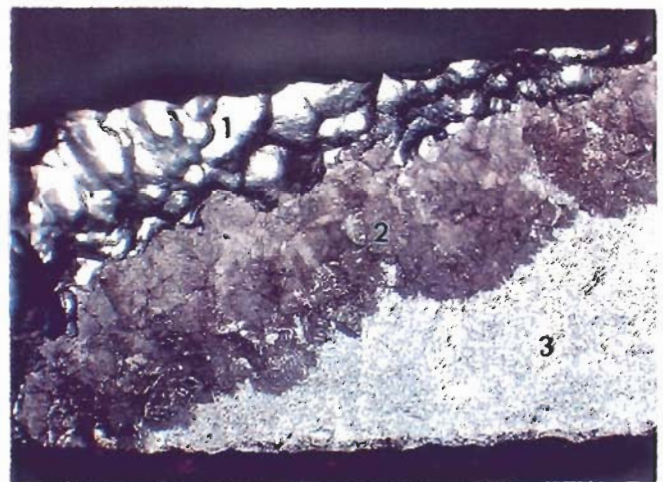
Figure 9 – The linear defect fracture surface exhibits three distinct regions. (8.8X)

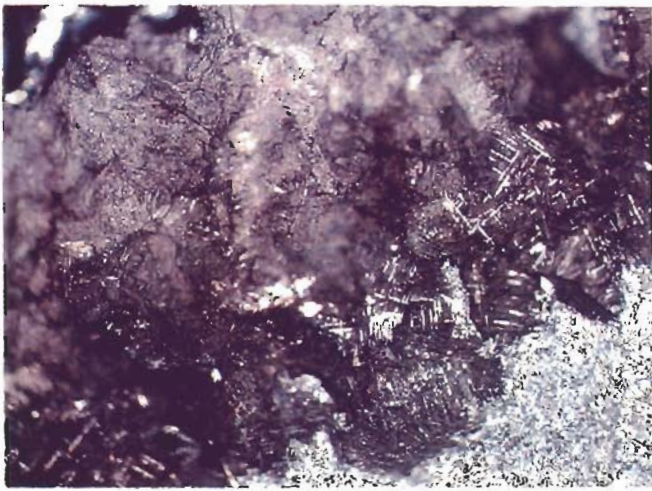
Figure 10 – Closer view of the solidification crack fracture surface. Note the Widmanstätten structure. (24X)

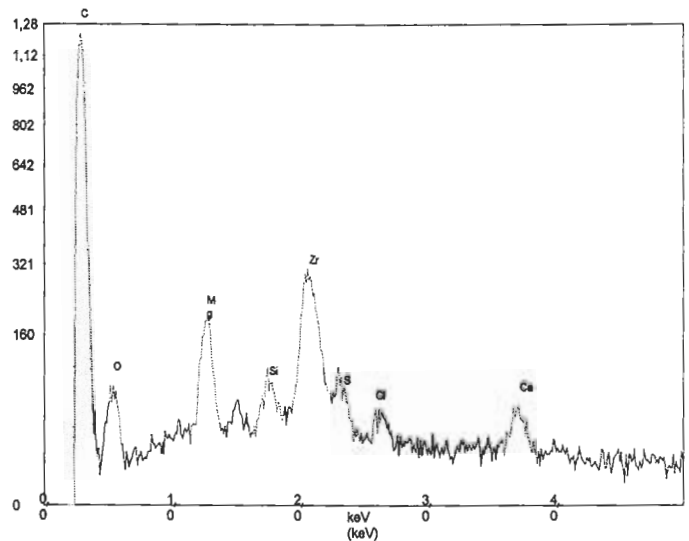
Figure 11 – EDS chemical analysis of the black deposit within a linear defect reveals high carbon from the graphite casting mold.

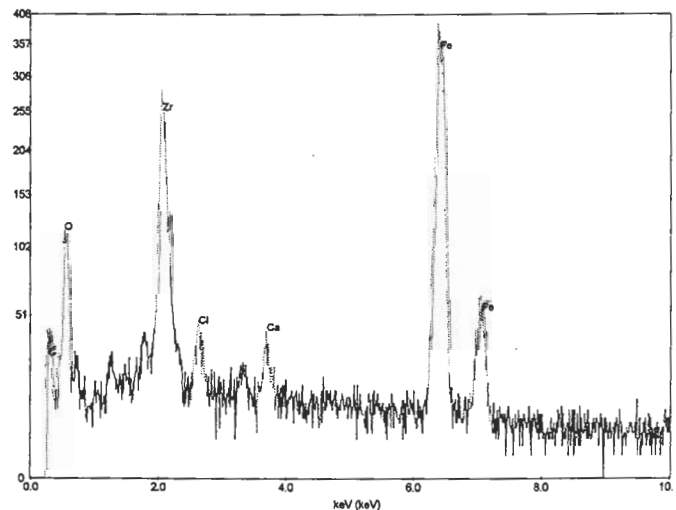
Figure 12 – EDS chemical analysis reveals iron-rich debris in the open-mouth portion of a linear defect.
