Epoxies Used in Tensile Testing: Film vs. Liquid-Why is There a Difference?

John P. Sauer

Sauer Engineering, Cincinnati, Ohio, USA

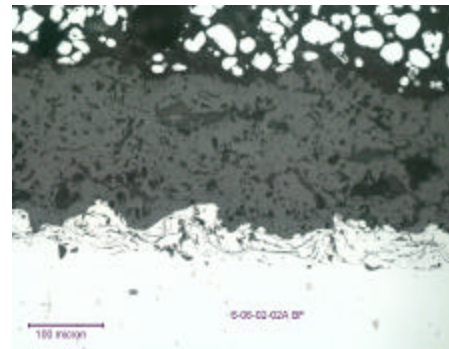
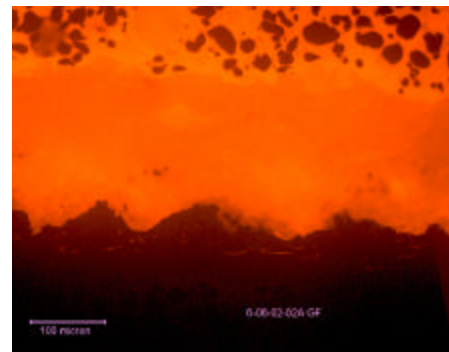
Figure 1: Plasma TBC-mounted with fluorescent dye-untested button-both bright field (a) and fluorescent filter (b).

Metallographic work was performed on both untested and tested buttons. Figures 1 thru 3 represent the microstructure of the plasma TBC, plasma NiAl, and HVOF NiAl, respectively. The substrate is at the bottom in all photomicrographs. Mounting material with fluorescent dye was used to prepare the specimens as evidenced by the fluorescent filter photos shown in item (b) of Figs. 1 thru 3. The fluorescent filter pictures were produced using a green excitation filter with a wavelength of 530-550 nm. As expected, the plasma coatings exhibit substantial porosity with the voids filled by mounting material containing fluorescent dye.

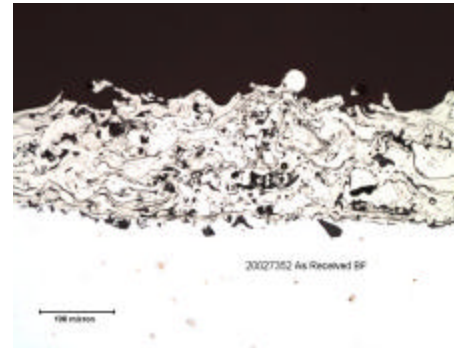
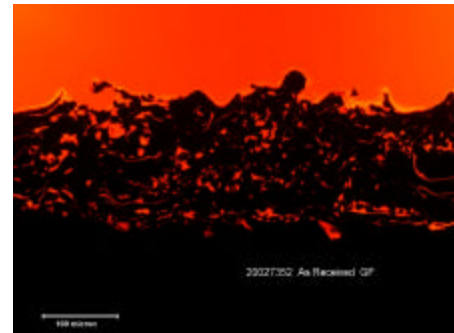
Figure 2: Plasma NiAl-mounted with fluorescent dye-untasted button-both bright field (a) and fluorescent filter (b).

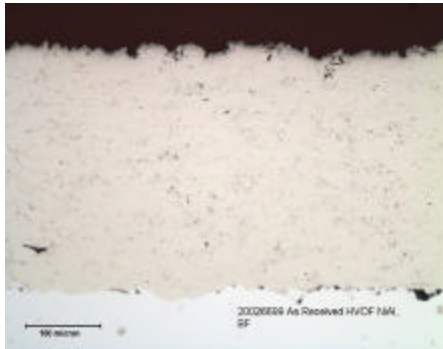
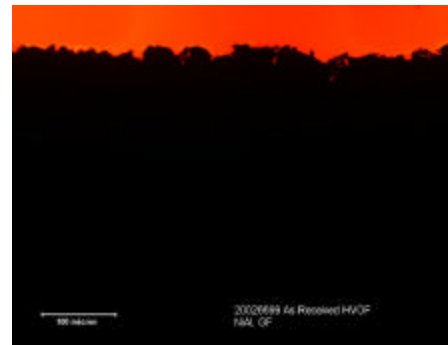
Figure 3: HVOF NiAl-untested button-both bright field (a) and fluorescent filter (b).

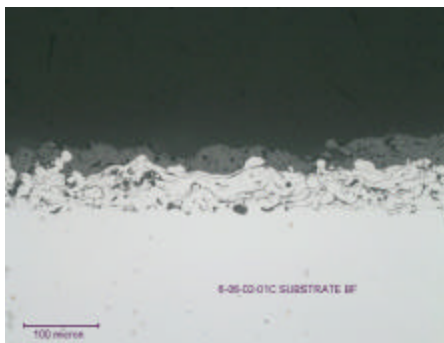
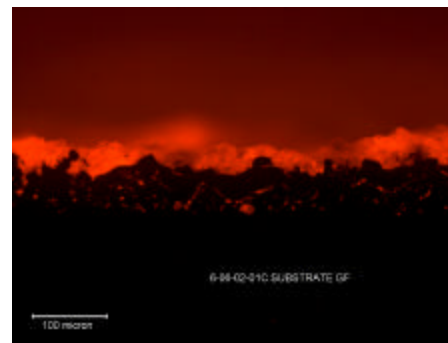
Figure 4: Plasma TBC-tested button with EC 2214 showing fluorescent epoxy from tensile adhesive in coating porosity-both bright field (a) and fluorescent filter (b).

Figures 4 thru 8 represent cross sections of the tested button specimens. Table 4 summarizes the results of the observations

Coating	Figure	Condition	Mounting Media	Logic	Actual Result
Plasma TBC	Figure 4	Tested with EC 2214 - <i>fluorescent dye</i> in tensile epoxy	<i>No dye</i> in mounting media	If fluorescent dye is viewed within the coating and there is no dye in the metallographic mount, the only source of the fluorescence is penetration of the liquid tensile epoxy.	Fluorescent dye is present in the mounted cross section-only source of dye is tensile epoxy - <u>data supports impregnation of tensile epoxy -failure location is also bottom 1/3 of coating.</u>
	Figure 5	Tested with FM 1000- <i>no dye</i> in tensile epoxy	<i>Fluorescent dye</i> in mounting media	If fluorescent dye is viewed within the coating, the only source would be the metallographic mounting material. This would indicate the FM 1000 material did not impregnate the coating during curing and the presence of dye in the coating is from the mounting material during vacuum impregnation.	Fluorescent dye is present in the mounted cross section-only source of dye is mounting material- <u>data supports no impregnation of tensile epoxy - failure location is also top 1/3 of coating.</u>

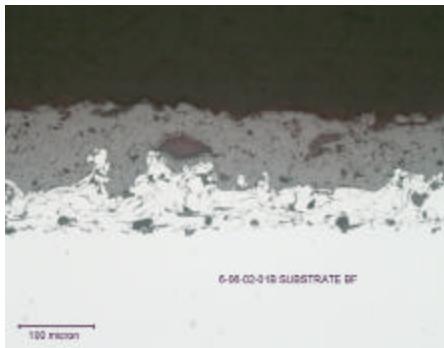
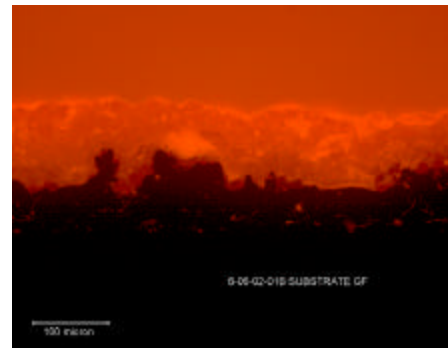
Figure 5: Plasma TBC-tested button with FM 1000 showing fluorescent epoxy from mounting material in coating porosity-both bright field (a) and fluorescent filter (b).

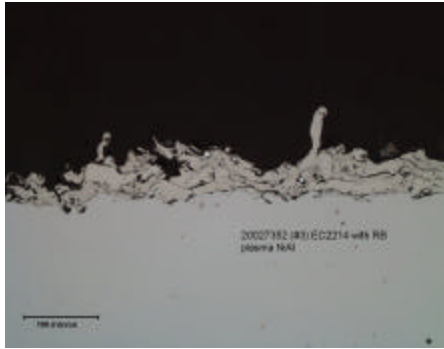
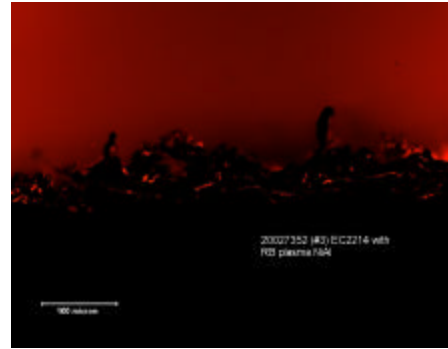
Figure 6: Plasma NiAl-tested button with EC 2214 showing fluorescent epoxy from tensile adhesive in coating porosity-both bright field (a) and fluorescent filter (b).

Plasma NiAl	Figure 6	Tested with EC 2214 - <i>fluorescent dye</i> in tensile epoxy	<i>No dye</i> in mounting media	If fluorescent dye is viewed within the coating and there is no dye in the metallographic mount, the only source of the fluorescence is penetration of the liquid tensile epoxy.	Fluorescent dye is present in the mounted cross section-only source of dye is tensile epoxy - <u>data supports impregnation of tensile epoxy.</u>
	Figure 7	Tested with FM 1000- <i>no dye</i> in tensile epoxy	<i>Fluorescent dye</i> in mounting media	If fluorescent dye is viewed within the coating, the only source would be the metallographic mounting material. This would indicate the FM 1000 material did not impregnate the coating during curing and the presence of dye in the coating is from the mounting material during vacuum impregnation.	Fluorescent dye is present in the mounted cross section-only source of dye is mounting material- <u>data supports no impregnation of tensile epoxy.</u>

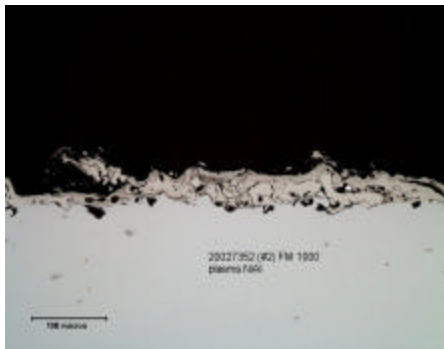
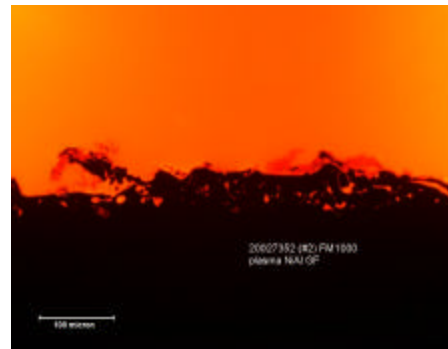
Figure 7: Plasma NiAl-tested button with FM 1000 showing fluorescent epoxy from mounting material in coating porosity-both bright field (a) and fluorescent filter (b).

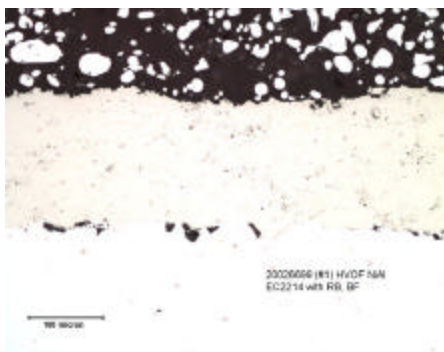
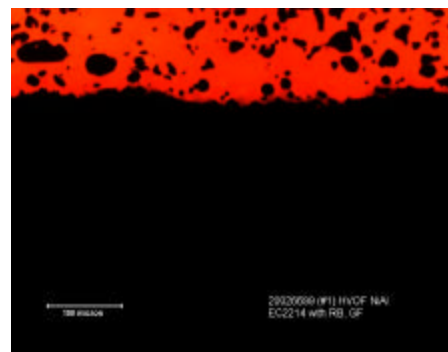
Figure 8: HVOF NiAl-tested button from either EC 2214 or FM 1000 showing no fluorescent epoxy from mounting material or tensile adhesive in coating porosity-both bright field (a) and fluorescent filter (b).

HVOF NiAl	Figure 8	Tested with EC 2214 - <i>fluorescent dye</i> in tensile epoxy	<i>No dye</i> in mounting media	If fluorescent dye is viewed within the coating and there is no dye in the metallographic mount, the only source of the fluorescence is penetration of the liquid tensile epoxy.	No fluorescent dye present in mounted cross section-failure was epoxy only in testing-coating is dense and no impregnation occurs -there was also no difference in tensile results with either epoxy
	Same as Figure 8	Tested with FM 1000- <i>no dye</i> in tensile epoxy	<i>Fluorescent dye</i> in mounting media	If fluorescent dye is viewed within the coating, the only source would be the metallographic mounting material. This would indicate the FM 1000 material did not impregnate the coating during curing and the presence of dye in the coating is from the mounting material during vacuum impregnation.	No fluorescent dye present in mounted cross section-failure was epoxy only in testing-coating is dense and no impregnation occurs -there was also no difference in tensile results with either epoxy
